Manhole Inspection Summary

Manhole # S41E__055MH

Insp Date: **10/3/08 10:34 AM**

Location Address: **n central ave**

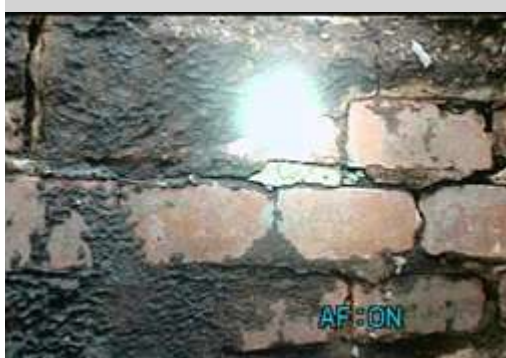
Defect 3

Condition: ☐ Sound ☒ **Cracked** ☐ Root Intrusion ☐ Loose Brick ☐ Deteriorated

Infiltration: ☐ None ☐ Joint ☐ Cracks ☐ Mortar ☐ Roots ☒ **Wall**

Cracked Corbel, Infiltration in Corbel

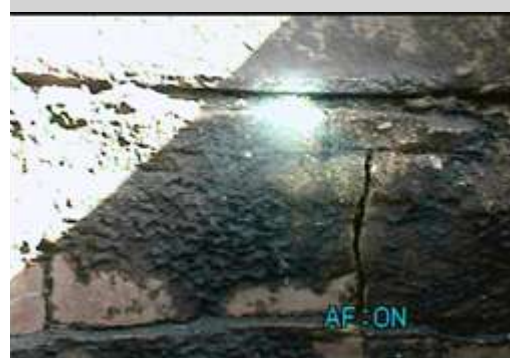
Defect 2

Condition: ☐ Sound ☒ **Cracked** ☐ Root Intrusion ☐ Loose Brick ☒ **Deteriorated**

Infiltration: ☐ None ☒ **Joint** ☐ Cracks ☐ Mortar ☐ Roots ☐ Wall

Cracked Chimney, Joint Infiltration in Chimney

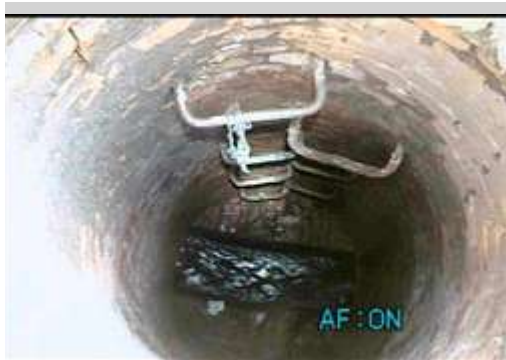
Defect 1

Count: **8** Missing: **0** ☒ **Corroded**

☒ **Evidence Of Surcharge** Depth: **6** (ft.) ☐ Active Surcharge Present

cor. steps, evidence of surcharge

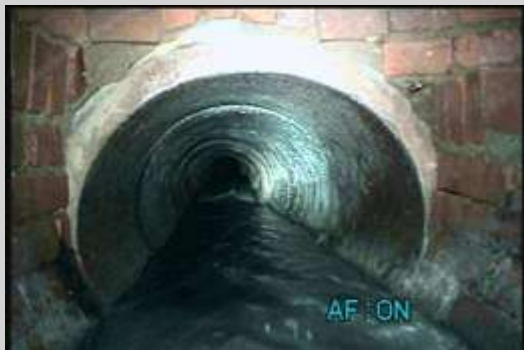
12 O'Clock Outflow

21 in. Circular Gravity Sewer
Pipe Out @ 12 O'Clock

Invert Depth: **14.75** (ft.) Flow Characteristics: **Fast**

Infiltration: **None** Pipe Seal Cond: **Unknown**

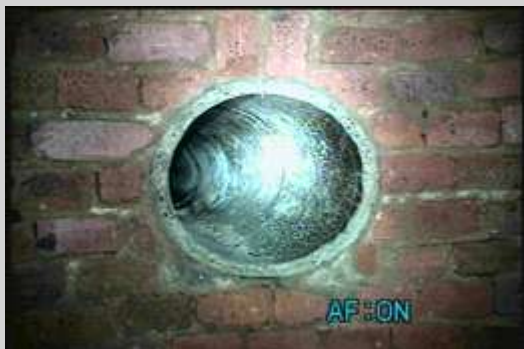
3 O'Clock Inflow

12 in. Circular Gravity Sewer
Pipe In @ 3 O'Clock

Invert Depth: **11.33** (ft.) Flow Characteristics: **Fast**

Infiltration: **None** Pipe Seal Cond: **Unknown**

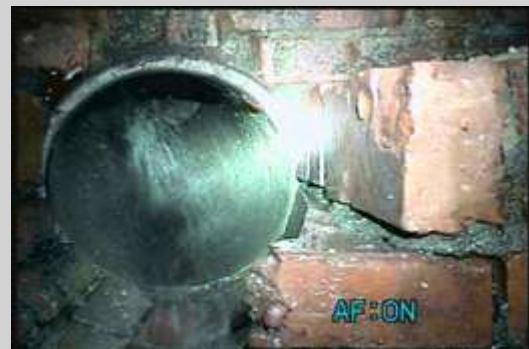
Drop In @ 3 O'Clock

Drop: **Outside Direct**

Inv Depth: **13.66** (ft.)

Drop Condition: **Open**

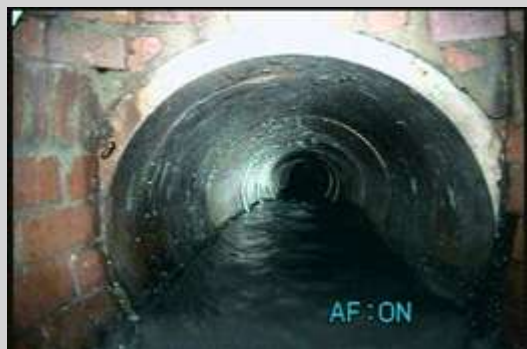
6 O'Clock Inflow

21 in. Circular Gravity Sewer
Pipe In @ 6 O'Clock

Invert Depth: **14.50** (ft.) Flow Characteristics: **Fast**

Infiltration: **None** Pipe Seal Cond: **Unknown**
